### **ASBESTOS SURVEY**

54 W. Lincoln Avenue  
Delaware, Ohio 43015  
Delaware County

#213404

January 11, 2022

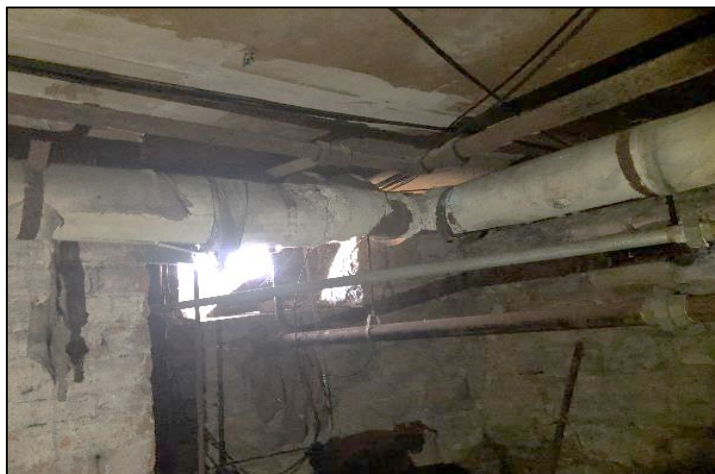
**Photograph No. 3**

This friable material was found only in the basement on a limited number of heating pipes. According to laboratory results, the piping run insulation contains 65% chrysotile asbestos. In total, there is approximately 60 linear feet of the material with areas of insulation that have fallen off the pipe and are laying on the floor. Therefore, this insulation must be removed by an Ohio-Certified Asbestos Abatement Contractor before the structure is renovated or demolished.

This friable material was found only in the basement on a limited number of heating pipes. According to laboratory results, the piping fitting and elbow insulation contains 45% chrysotile asbestos. In total, there are only a few fittings or elbows in the southeast corner of the basement. However, this insulation must be removed by an Ohio-Certified Asbestos Abatement Contractor before the structure is renovated or demolished.

Insulation remains on some of the heating piping in the basement.

Therefore, prior to any planned renovation or demolition of the facility, those materials must be removed by an Ohio-Certified Asbestos Abatement Contractor.

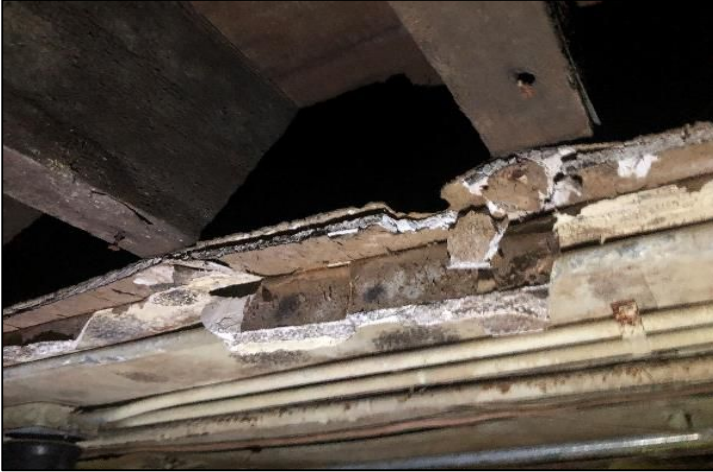
**Photograph No. 4**

The ceiling of the basement beneath the original home includes a cementitious board with a plaster-like coating.

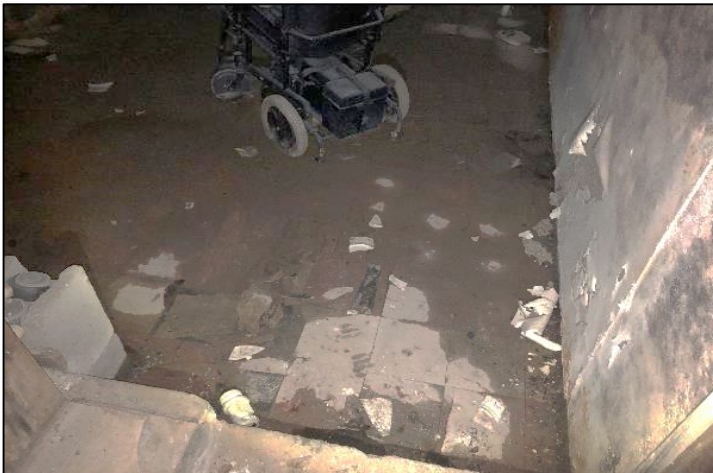
**Photograph No. 5**

This material was found only in two rooms in the basement of the original home. According to laboratory results, this flooring contains 7% chrysotile asbestos. In total, there is approximately 500 square feet of the flooring found in the basement. Therefore, this tile flooring must be removed by an Ohio-Certified Asbestos Abatement Contractor before the structure is renovated or demolished.

9"x9" red floor tiles are located in multiple rooms in the basement.

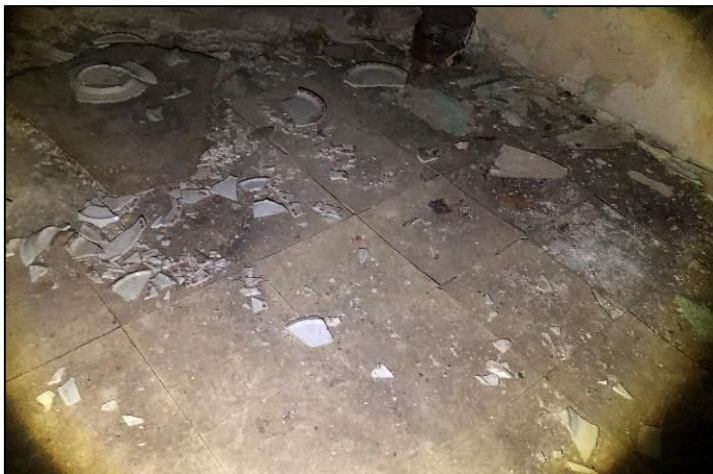
**Photograph No. 6**

This material is associated with the 12"x12" white vinyl floor tile that was found throughout the patient rooms, basement and limited hallways of the facility. According to laboratory results, this black mastic contains 5% chrysotile asbestos while the floor tile itself contains no asbestos. In total, there is over 4,000 square feet of the mastic found in the facility. Most of this flooring is in poor condition, particularly in the basement and the single-story addition. Therefore, this material must be removed by an Ohio-Certified Asbestos Abatement Contractor before the structure is renovated or demolished.

12"x12" white floor tile is located in the basement hallway.

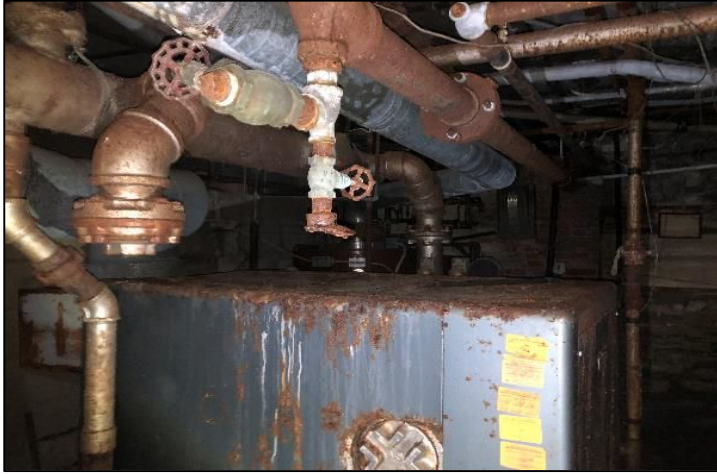
**Photograph No. 7**

Overview of the boiler room which appears to have had all piping insulation removed.

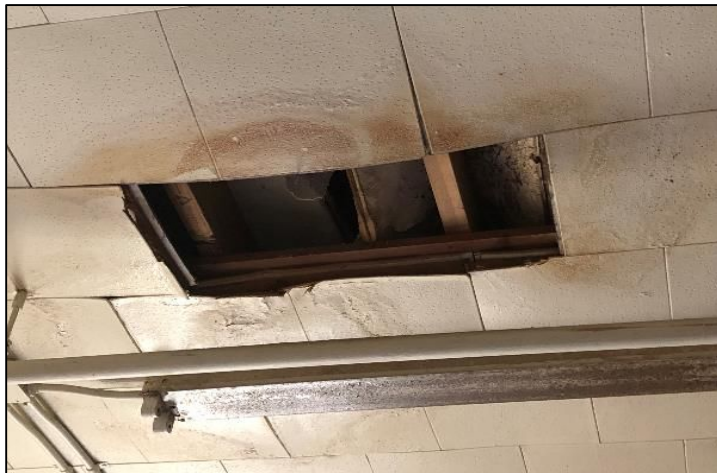
**Photograph No. 8**

12"x12" fiberboard ceiling tiles were found on the first floor adjacent to the kitchen.

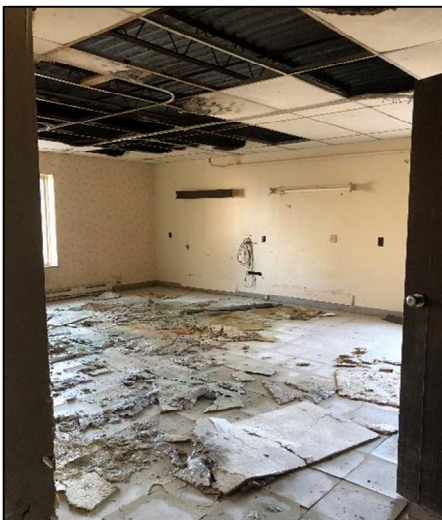
**Photograph No. 9**

Typical first floor addition materials with water damaged lay-in ceiling tile, 12"x12" floor tile, and drywall.

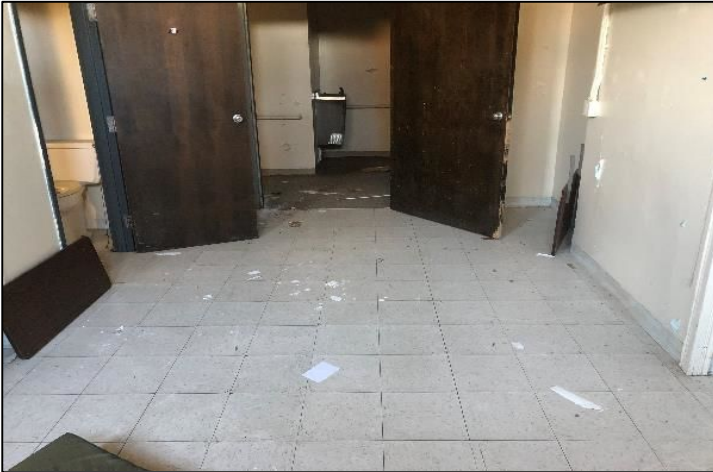
**Photograph No. 10**

White floor tile on the first floor.

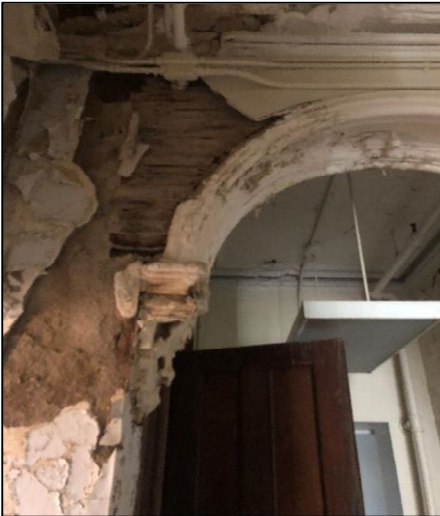
**Photograph No. 11**

Second floor of the original home with old plaster over wood lath and decorative plaster moldings.

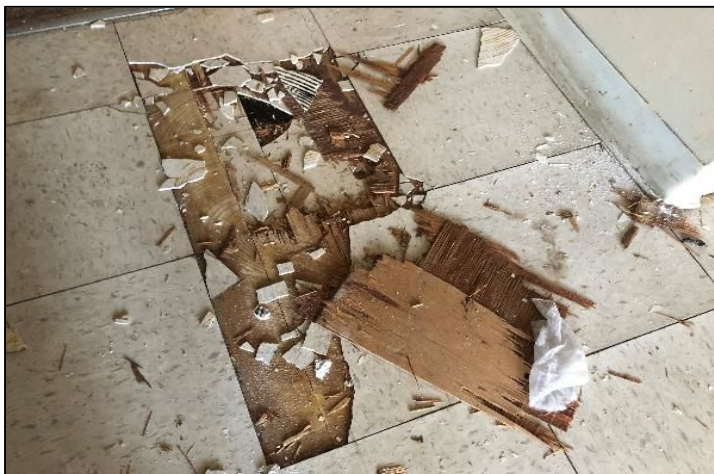
**Photograph No. 12**

Second floor with two layers of floor tile.

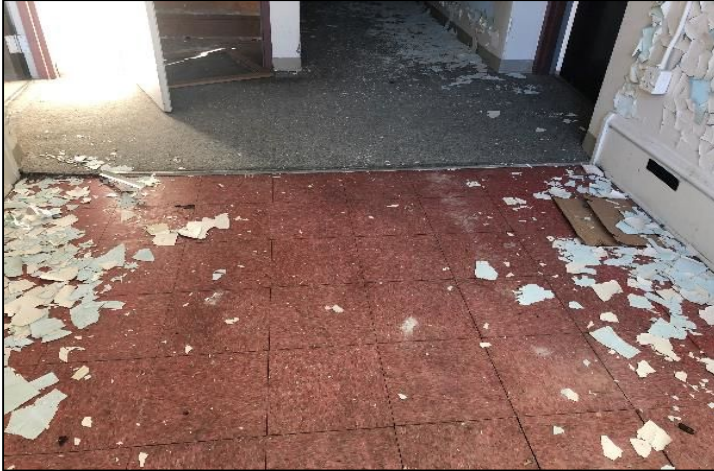
**Photograph No. 13**

This material is associated with the 12"x12" red vinyl floor tile that was found at the south end of the second-floor hallway in the original home. According to laboratory results, this black mastic contains 5% chrysotile asbestos while the floor tile itself contains no asbestos. In total, there is approximately 150 square feet of the mastic found on the second floor. This material must be removed by an Ohio-Certified Asbestos Abatement Contractor before the structure is renovated or demolished.

Red floor tile at the front or south side of the second floor hallway.

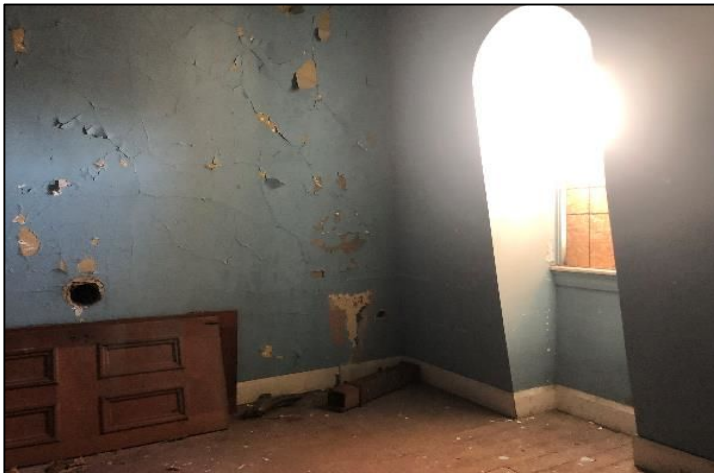
**Photograph No. 14**

Typical third floor conditions with damaged plaster and wood floors.
